# QUIET CLEAN SHORT-HAUL EXPERIMENTAL ENGINE (QCSEE)

# UNDER-THE-WING ENGINE COMPOSITE FAN BLADE FINAL DESIGN TEST REPORT

February 1977

Advanced Engineering & Technology Programs Department
General Electric Company

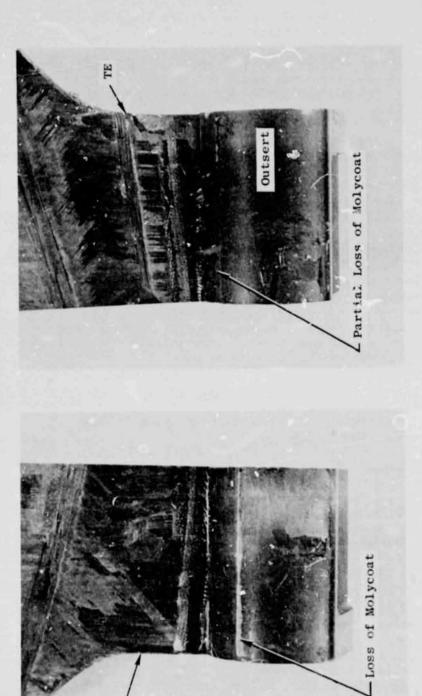
Posttest inspection of the blades consisted of ultrasonic C scanning, die penetrant examination and frequency measurement. Die penetrant inspection of blade Q7 showed signs of a crack in the trailing edge dovetail face. Ultrasonic inspection showed no signs of delamination and frequency measurement showed roloss in frequency. It was concluded that the blade was not structurally damaged. The ultrasonic, die penetrant and frequency inspection of blade Q6 showed no signs of damage and no loss in frequency. The molycoated aluminum outsert of blade Q6 showed signs of wear and local loss of the molycoat along a chordwise line that coincides with the trunnion interface. This is shown in Figure 25.
